Manhole Inspection Summary

Manhole # S37Q__013MH

Insp Date: **1/23/08 2:19 PM**

Location Address: **402 sanders st**

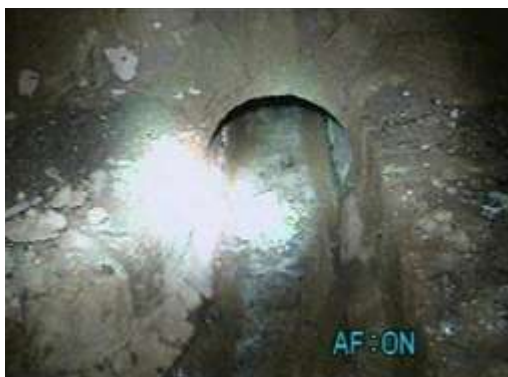
Misc

channel debris

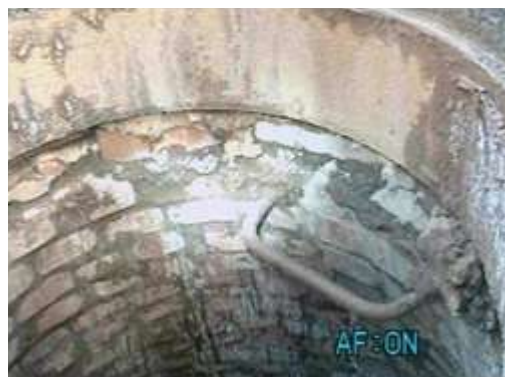
Defect 2

Condition: ☐ Sound ☐ Cracked ☒ **Leaks**

Condition: ☐ Sound ☐ Cracked ☐ Root Intrusion ☒ **Loose Brick** ☐ Deteriorated

Infiltration: ☐ None ☒ **Joint** ☐ Cracks ☐ Mortar ☐ Roots ☐ Wall

corbel loose bricks, inflow evidence, infiltration in frame joint, offset

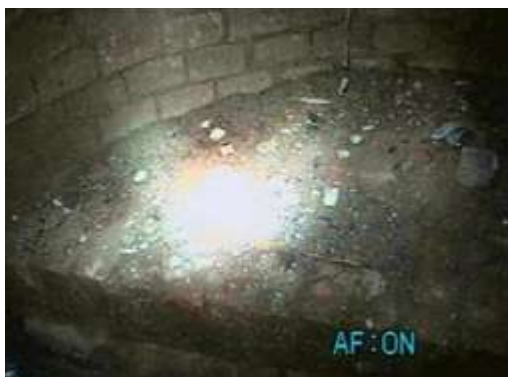
Defect 1

Condition: ☐ Sound ☐ Cracked ☐ Root Intrusion ☐ Deteriorated ☐ Leaks ☒ **Debris**

bench debris

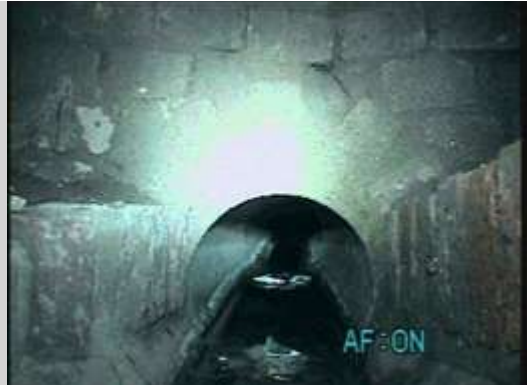
12 O'Clock Outflow

8 in. Circular Gravity Sewer
Pipe Out @ 12 O'Clock

Deposits: ☐ None ☐ Mud ☐ Sludge ☒ **Debris** ☐ Grease

Silt Depth: **1** (in.) Deposits Extent: **Light**

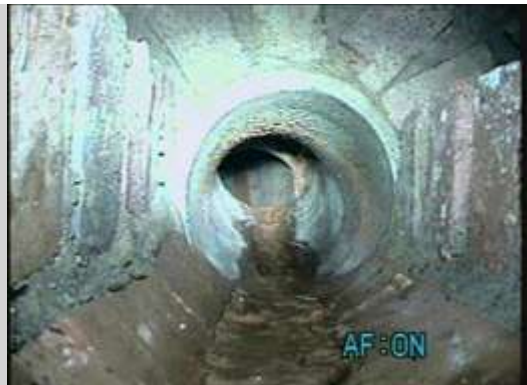
6 O'Clock Inflow

8 in. Circular Gravity Sewer
Pipe In @ 6 O'Clock

Deposits: ☐ None ☒ **Mud** ☐ Sludge ☐ Debris ☐ Grease

Silt Depth: **1** (in.) Deposits Extent: **Light**
